15. Passive House Conference, Innsbruck 27./28.05.2011

Biomass façade insulation for existing buildings

Retrofit of Rotlintstraße 116-128 in Frankfurt, Main, Germany

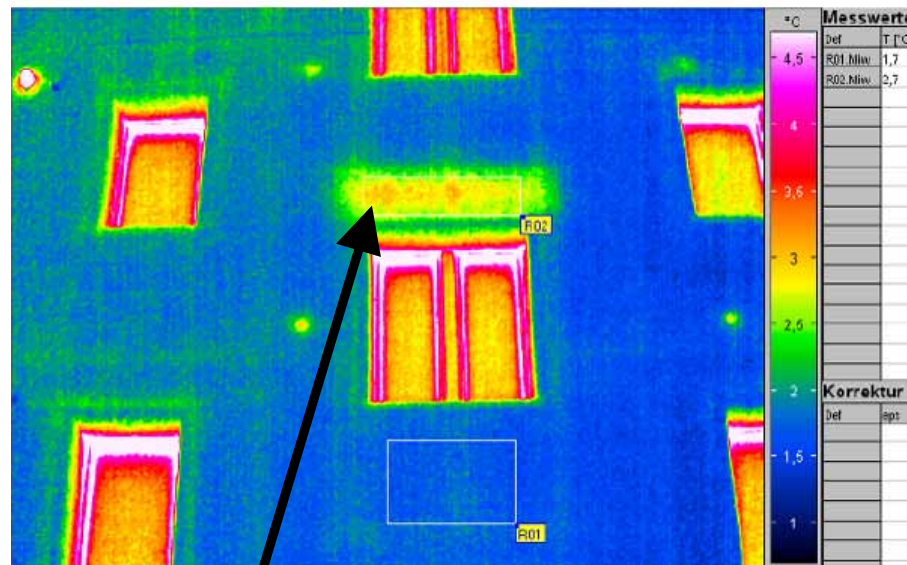
Feb 2010

Directly above some windows
some hollow spaces were not
insulated
